DEPARTMENT OF TRANSPORTATION**DIVISION OF ENGINEERING SERVICES**

Contract #: 04-0120F4Cty: SF/ALA Rte: 80 PM: 13.2/13.9File #: 1.28**WELDING INSPECTION REPORT****Resident Engineer:**Siegenthaler, Peter**Address:** 333 Burma Road**City:** Oakland, CA 94607**Report No:** WIR-026156**Date Inspected:** 24-Aug-2011**Project Name:** SAS Superstructure**OSM Arrival Time:** 700**Prime Contractor:** American Bridge/Fluor Enterprises, a JV**OSM Departure Time:** 1730**Contractor:** American Bridge/Fluor Enterprises, a JV**Location:** Job Site**CWI Name:** See Below**CWI Present:** Yes No**Inspected CWI report:** Yes No N/A**Rod Oven in Use:** Yes No N/A**Electrode to specification:** Yes No N/A**Weld Procedures Followed:** Yes No N/A**Qualified Welders:** Yes No N/A**Verified Joint Fit-up:** Yes No N/A**Approved Drawings:** Yes No N/A**Approved WPS:** Yes No N/A**Delayed / Cancelled:** Yes No N/A**Bridge No:** 34-0006**Component:** SAS Tower & OBG**Summary of Items Observed:**

A). Tower Shear Plates

B). OBG E11/E12

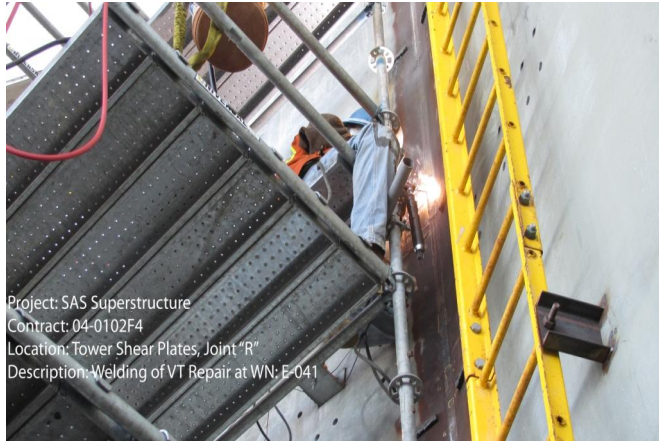
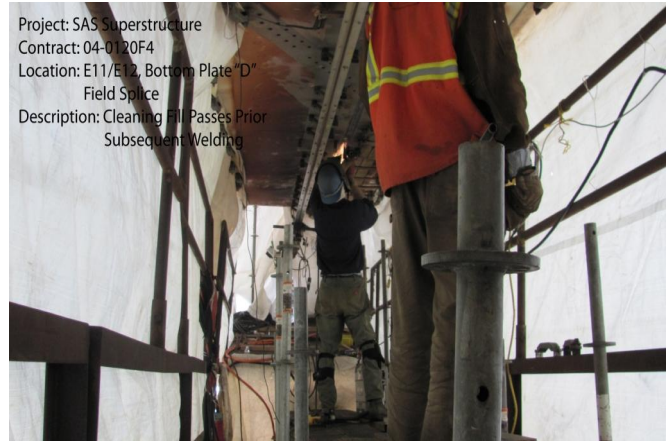
The digital photographs on page 3 of this report illustrate some of the work observed during this scheduled work date.
